92-97 4R70W repin for using 98-08 trans:

In 98 the hard connector replaced the internal wire harness...and a repin or solenoid swap is required. The following info is regarding a repin of the 92-97 chassis harness.

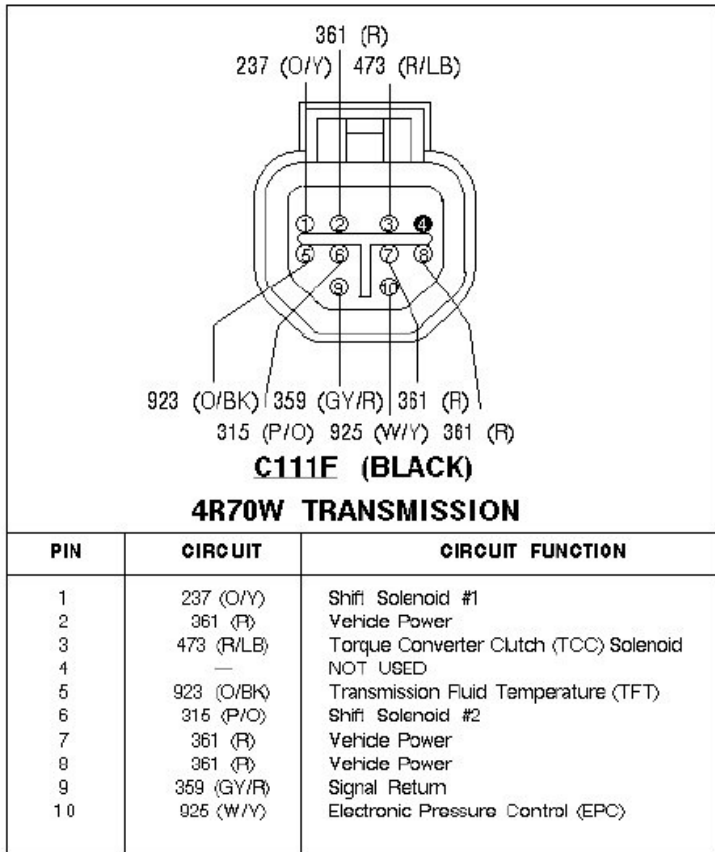
1992-1997

Here is the factory diagram looking INTO the chassis connector.

In the 92-97 chassis harness connector, using small screw driver, disassemble the connector all the way down to the internal rubber insulator. Remove and place these wires...color can vary, so I describe in terms of position.

-
- 10 to 6
- 9 to 2
- 8 to 10 or leave out
- 7 to 9 or leave out
- 6 to 8
- 5 no change
- 4 in blank now, put 2 here
- 3 no change
- 2 to 4 (12v+)
- 1 to 7
